**Subject: Removal Action Report – Revision 1
Nelson Knitting Site – RV
Rockford, Winnebago County, Illinois
EPA Contract Number: 68HE0519D0005
Task Order – Task Order Line-Item Number (TO-TOLIN): F0032-0001DL101
Document Tracking Number: 1588a**

REMOVAL ACTION REPORT

NELSON KNITTING SITE – RV

Revision 1
April 25, 2023

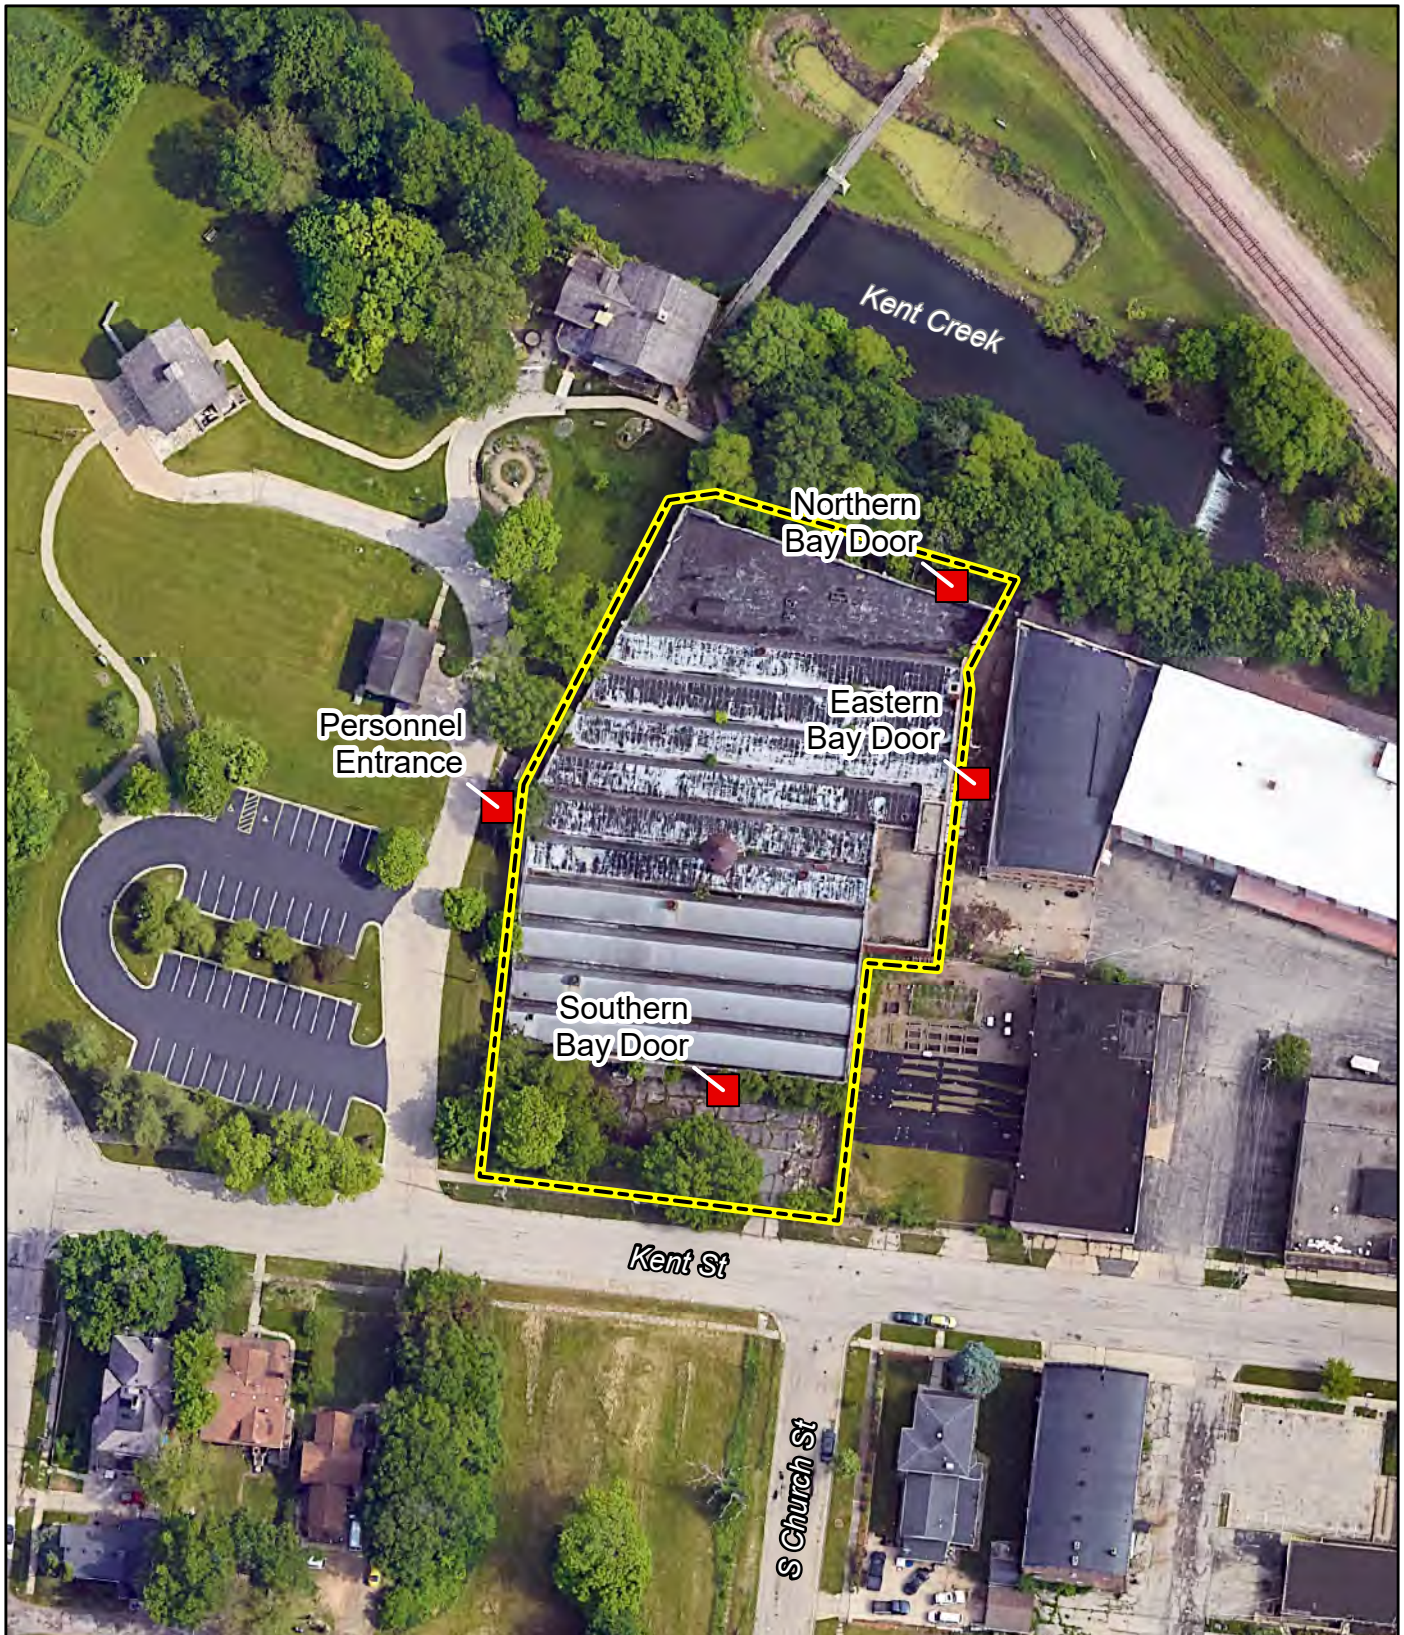
Figure 4
Air Monitoring Locations

START also established four monitoring locations at the site perimeter: one outside the CRZ entrance (personnel entrance), one outside the southern bay door near the staged roll-off box, one outside the eastern bay door leading to the basement, and one outside the northern bay door leading to the boiler room, (Appendix A, Figure 4). The station for the personnel entrance was deployed daily when weather permitted, but the southern, northern, and eastern bay door stations were only deployed when the respective doors were opened for removal activities. Each monitoring station consisted of a TSI DustTrak DRX 8533EP particulate monitor (DustTrak) equipped with telemetry equipment, a Gillian AirCon2 high-volume air sampling pump, and a generator, solar panel, or external battery to provide power.

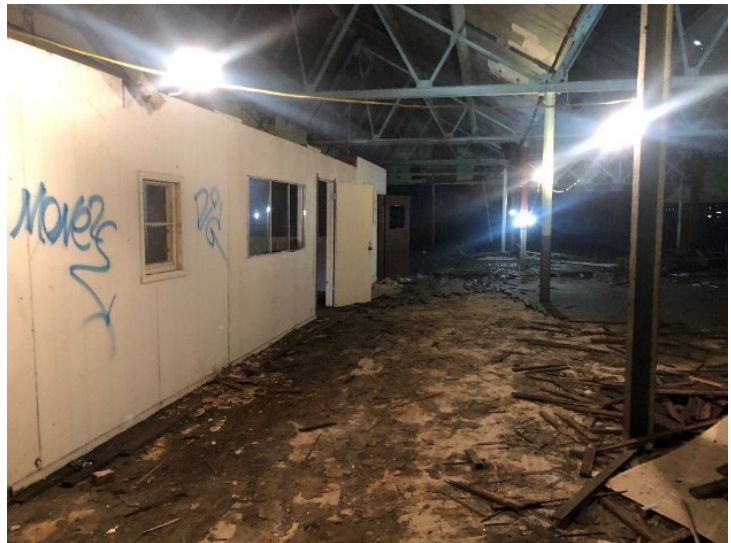
Photograph 7

Description: Initial conditions on the southern side of the main floor of the building, with the southern bay door visible in the background

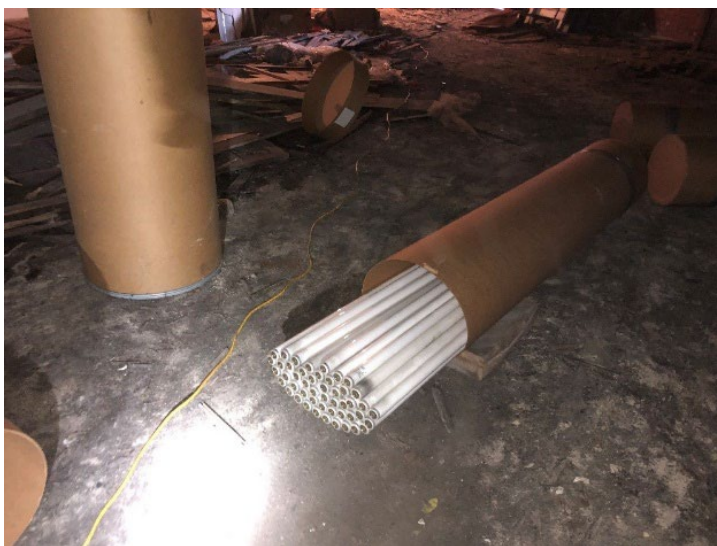
Photograph 11

Description: Initial conditions on the basement level of the building

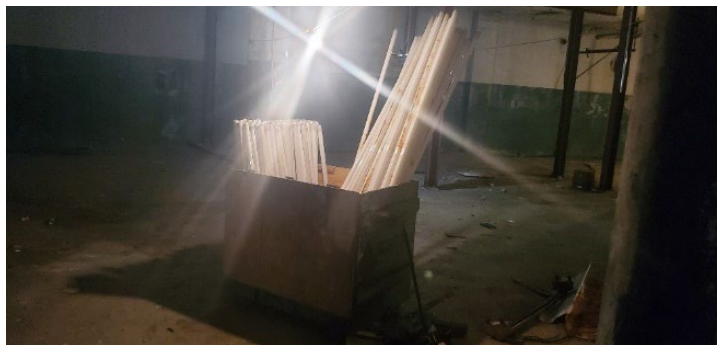
Photograph 16

Description: Bay door opening into the alleyway on the eastern side of the building

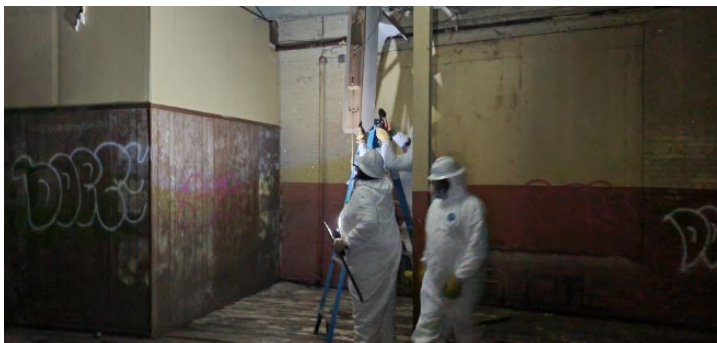
Photograph 19

Description: Close-up of a PCB ballast

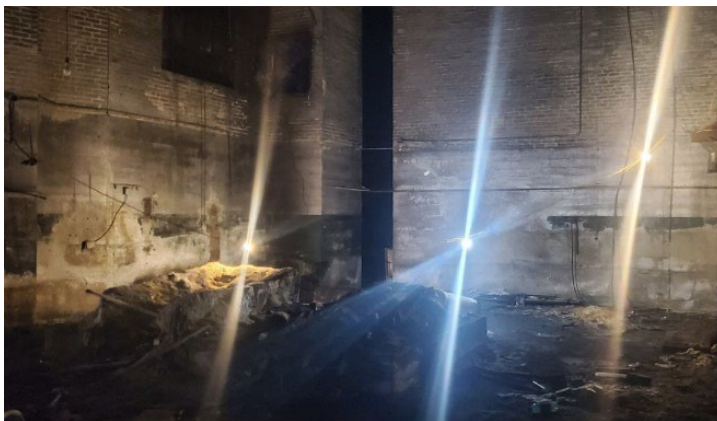
Photograph 23

Description: Boiler room initial conditions; hazard hole in the northwestern corner of the room

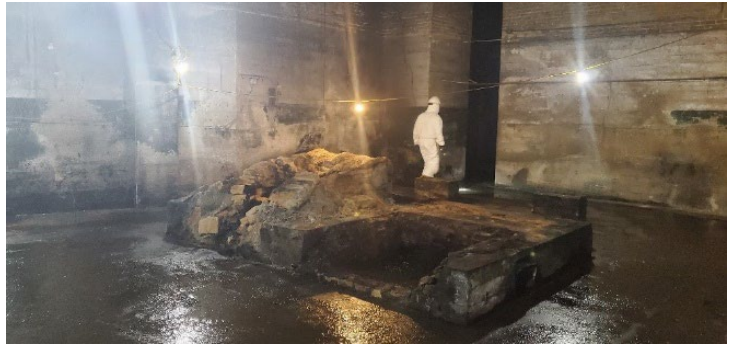
Photograph 42

Description: Boiler room conditions following ACM removal activity

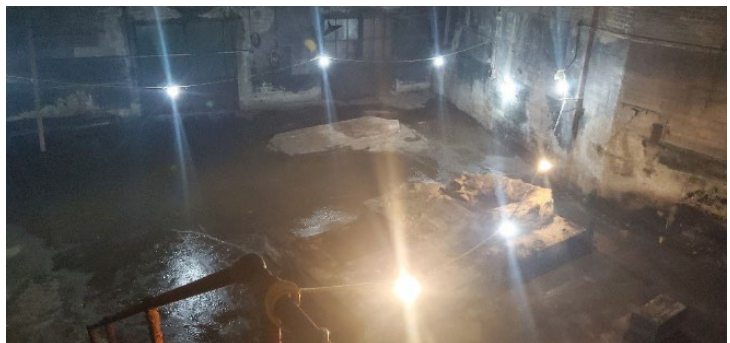
Photograph 44

Description: Boiler room conditions following ACM removal activity

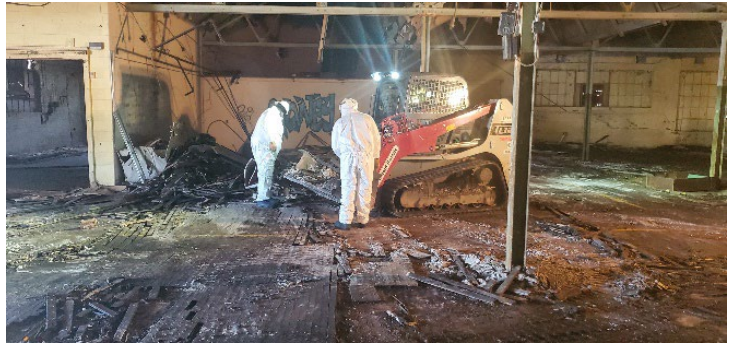
Photograph 45

Description: EQM using a skid-steer to collect large amounts of ACM on the main floor of the building

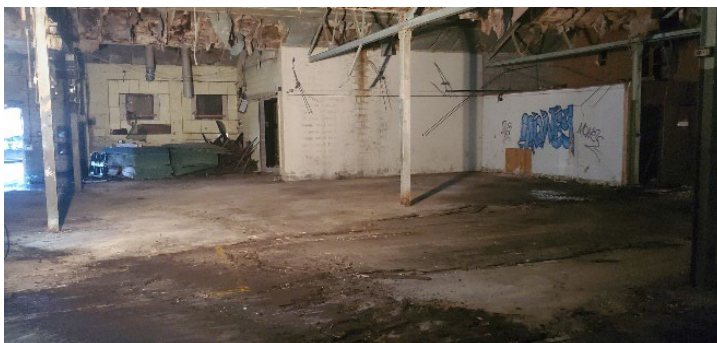
Photograph 50

Description: Main floor after ACM removal activities

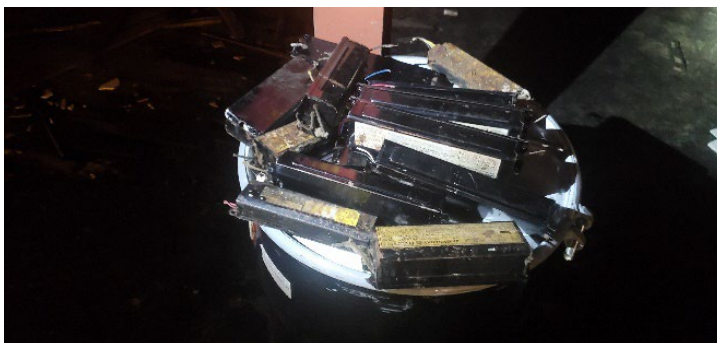
Photograph 52

Description: Total accumulation of PCB light ballasts, enough to fill one 55-gallon drum with additional ballasts on the lid

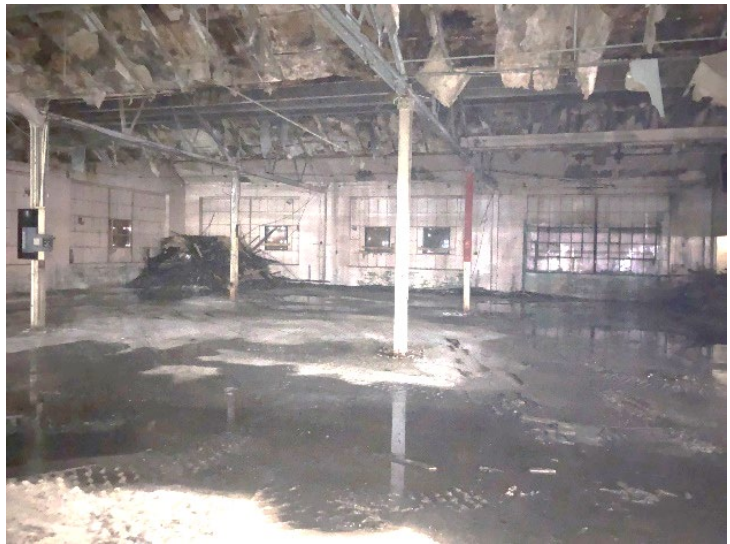
Photograph 63

Description: Condition of the southeast corner of the main floor of the building after ACM removal activities

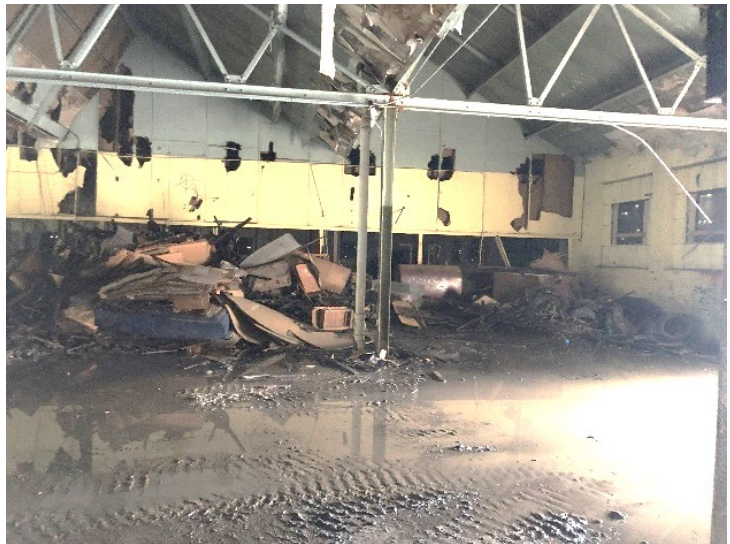
Photograph 69

Description: Accumulation on the main floor of the building of debris that was deemed to not contain any asbestos

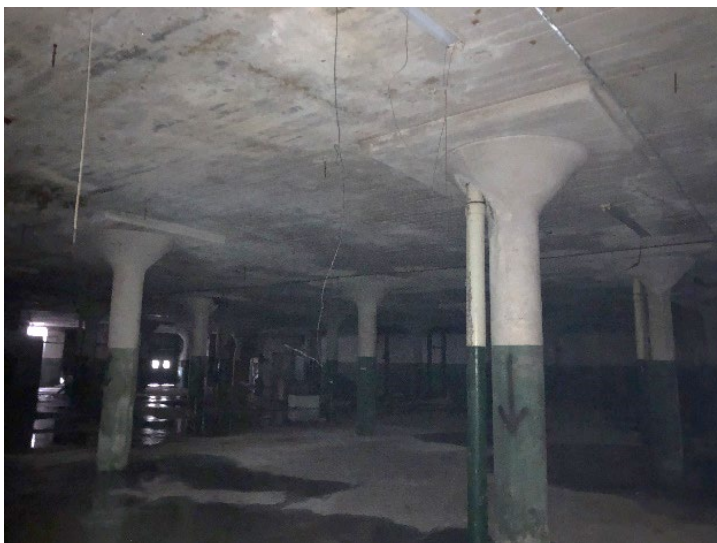
Photograph 73

Description: Condition of the ceiling on the basement level after all PCB ballasts and fluorescent tube lamps had been removed
